UNDER PERFORMANCE CLAIM VERIFICATION

Vessel : Bulk Carrier

Scope of assessment

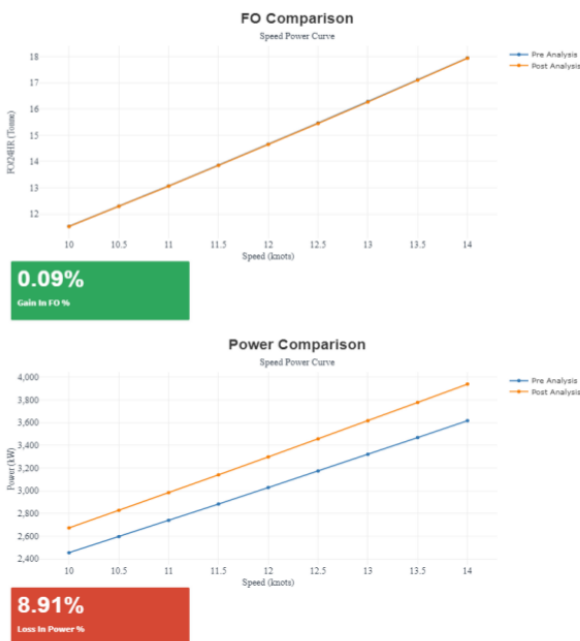
But in contrast to the Fuel analysis result, the vessel was showing an 8% increase in the required power after the modification, which implied that the modification was a loss in terms of power.

As XShip gives the result based on the underlying relationship between Fuel and Power with the vessel operating conditions and environmental conditions, The gain/loss in power and fuel must be analogous. The large deviation in power and fuel results led to a detailed investigation and it was noticed that the power reported was high after the modification. The Xship results and conclusion prompted the technical managers to inquire with the vessel. The ship staff agreed that they were reporting a higher ME power to show the charterer that engine was operating at higher load as they were not making CP speed.
